**STRUCTURAL ASSESSMENT  
REPORT OF  
BUILDINGS 5 & 6  
BRICK PRESS BUILDING ,  
FORMER HOFFMANS  
BRICKWORKS  
72-106 DAWSON STREET,  
BRUNSWICK**

**PREPARED FOR  
94 Feet Property Development & Construction  
c/- Neoscape Pty Ltd  
Attention: Darren Woolf**

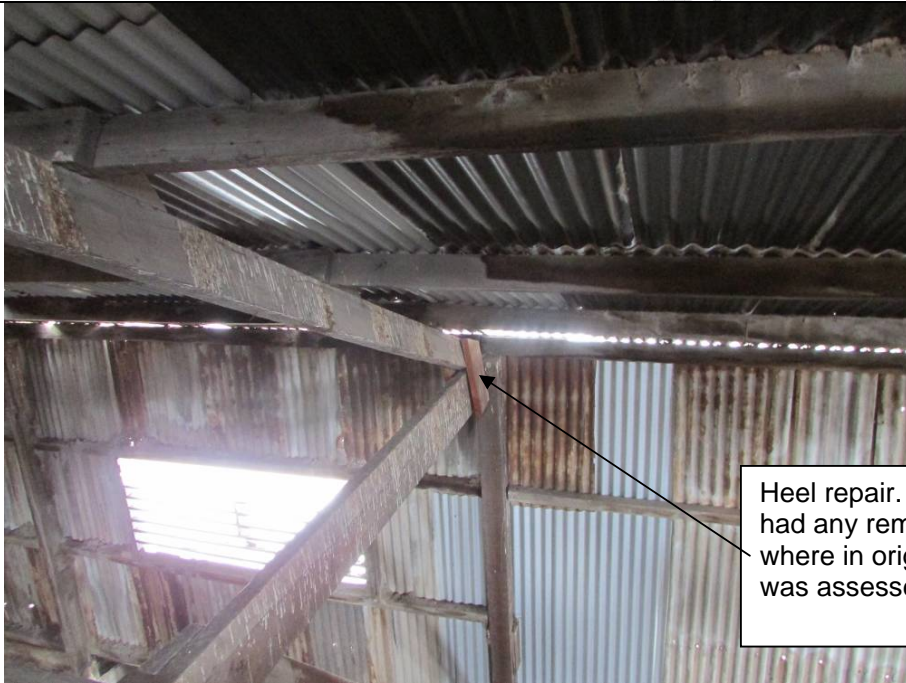
Roof Building 5 –

Heel repair. Of 8 trusses, only one had any remedial work. Others were in original condition , which was assessed to be good

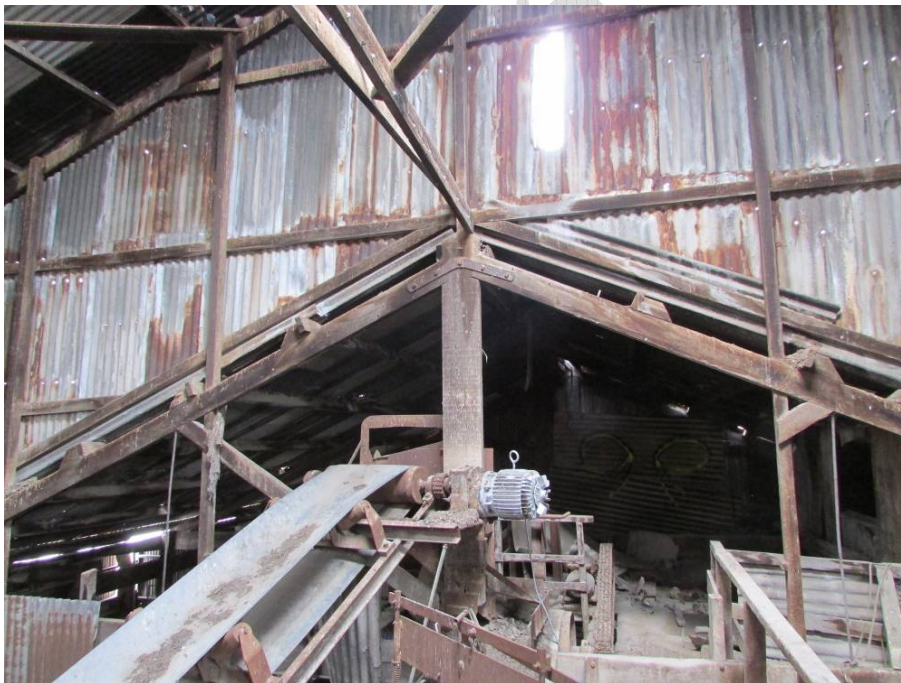
Roof Building 5 Typical Roof framing condition

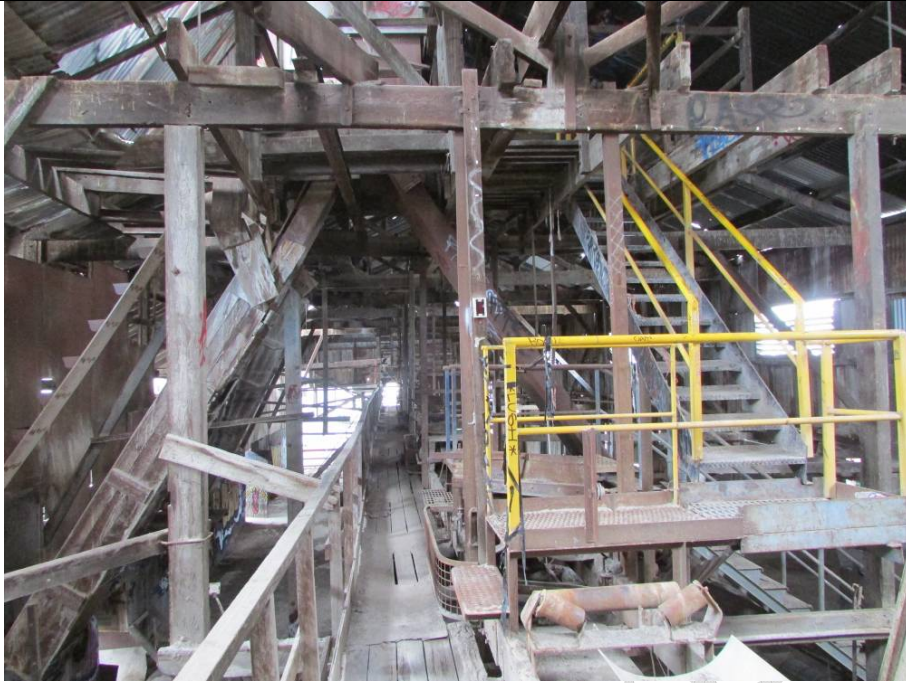
Roof Building 5 – Typical ad-hoc retrofitted mezzanine type industrial access framing, walkways and machinery supports

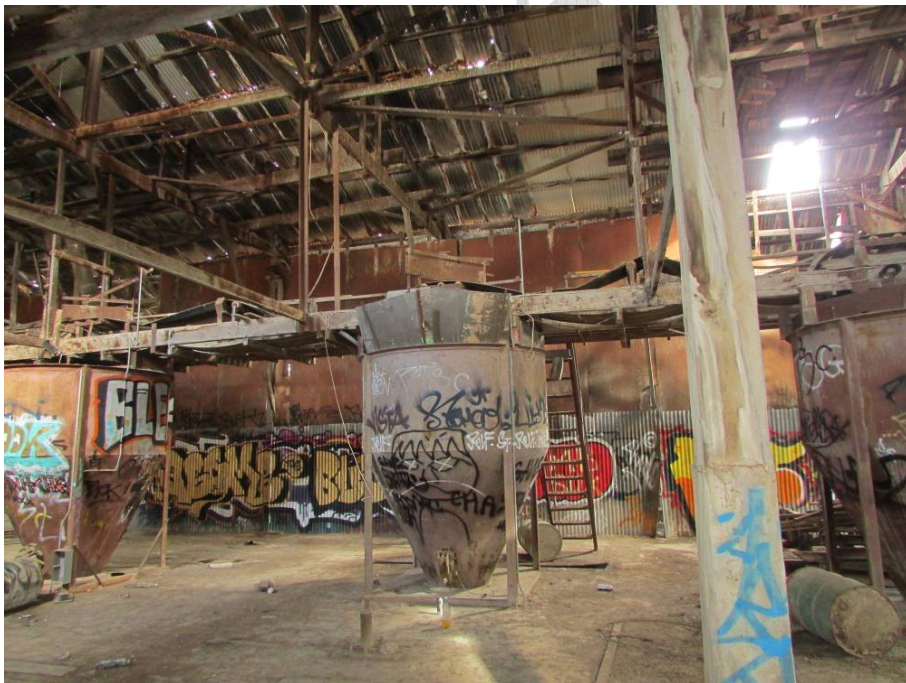
Floor Building 5 – Typical ad-hoc retrofitted mezzanine type industrial process access framing and hopper supports

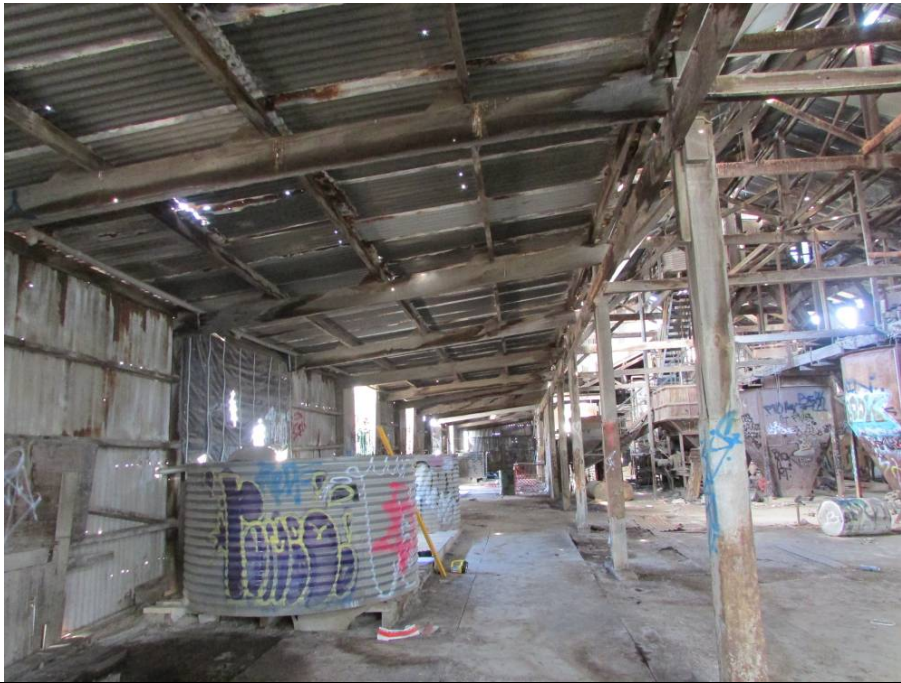
Building 5 – Lower Roof – East Wall Looking South  
 Note the water tanks , approximately 1.2m deep. Representing a potential load on the floor of 12 kPa. This may explain the crushed timber capitals under . Residential floor loads are 1.5 Kpa, Office floor loads are 3.0Kpa

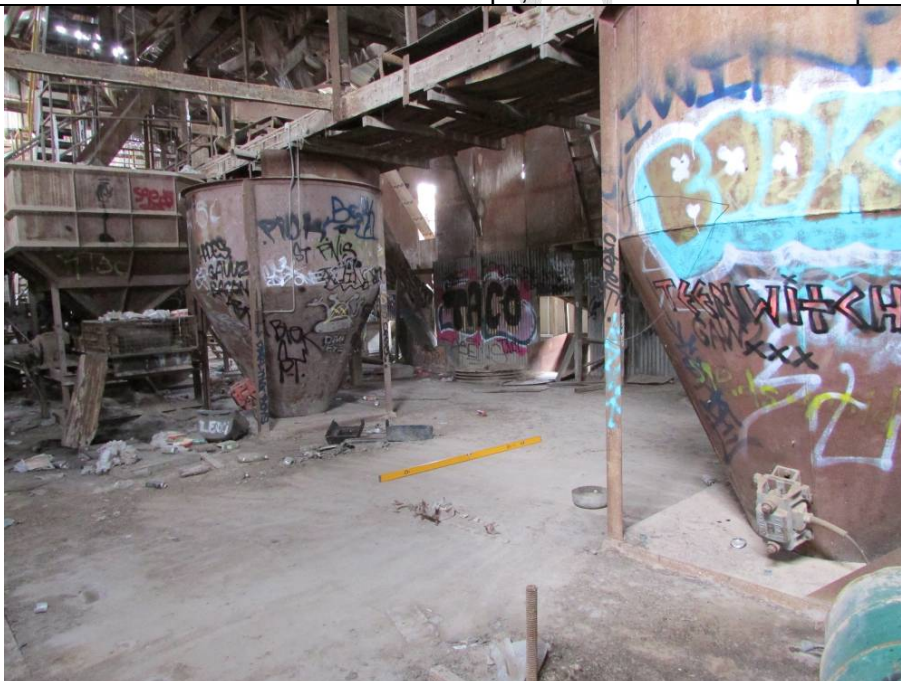
Building 5 – Floor sag condition. With a 2.0m level the floor sag was assessed to be less that 5 – 10mm below the level

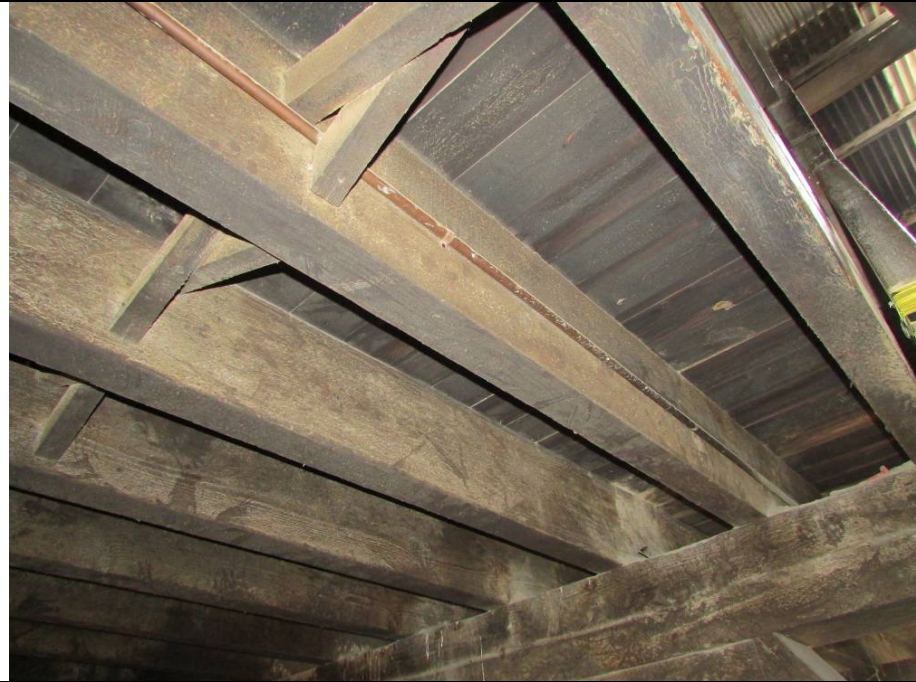
Building 5 – Typical first floor framing condition for majority of the floor. Water ingress has in areas had a detrimental affect on the floor joists

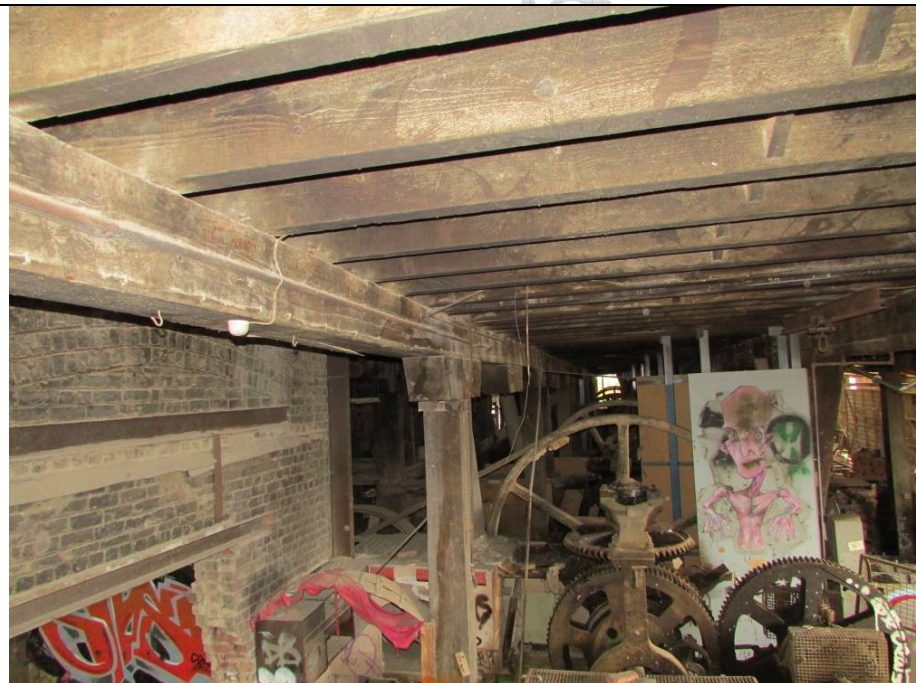
Building 5 – First floor framing looking North. 75- 85 % of the floor framing is in this conditions

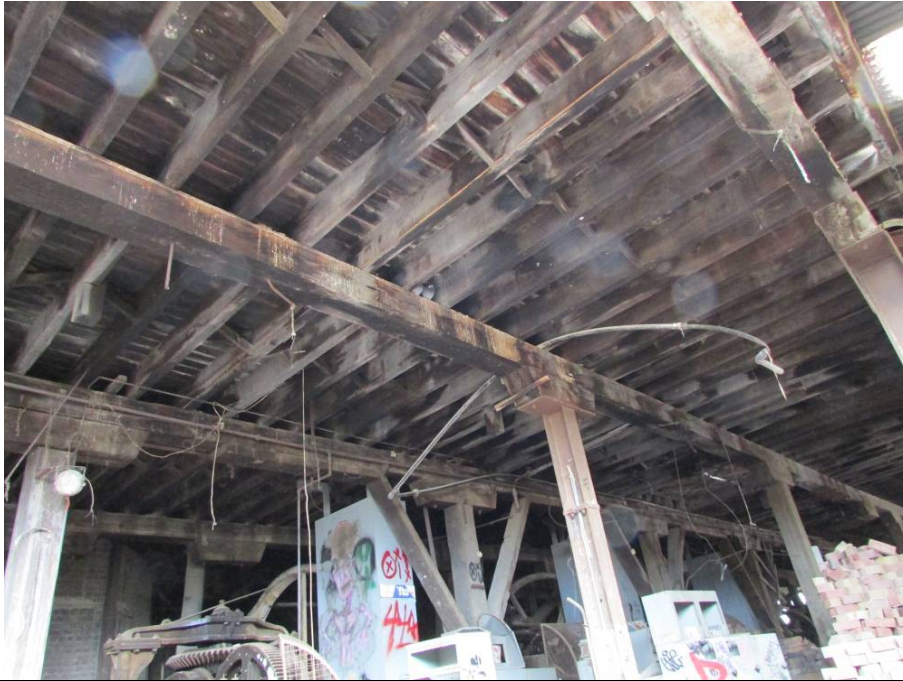
- m) In the area that the floor had disintegrated, the top edge of the timber floor joist had been adversely affected to depths of 25 – 45 mm . The degradation was of limited length and given the robust nature of the floor joists, the joist could be

Building 5 First floor framing. Discoloration of timber from prolonged exposure to ingress of water. Top edge of timber rotted to a depth of 25-30 mm in the places available to be inspected . Ad-hoc structural repairs.

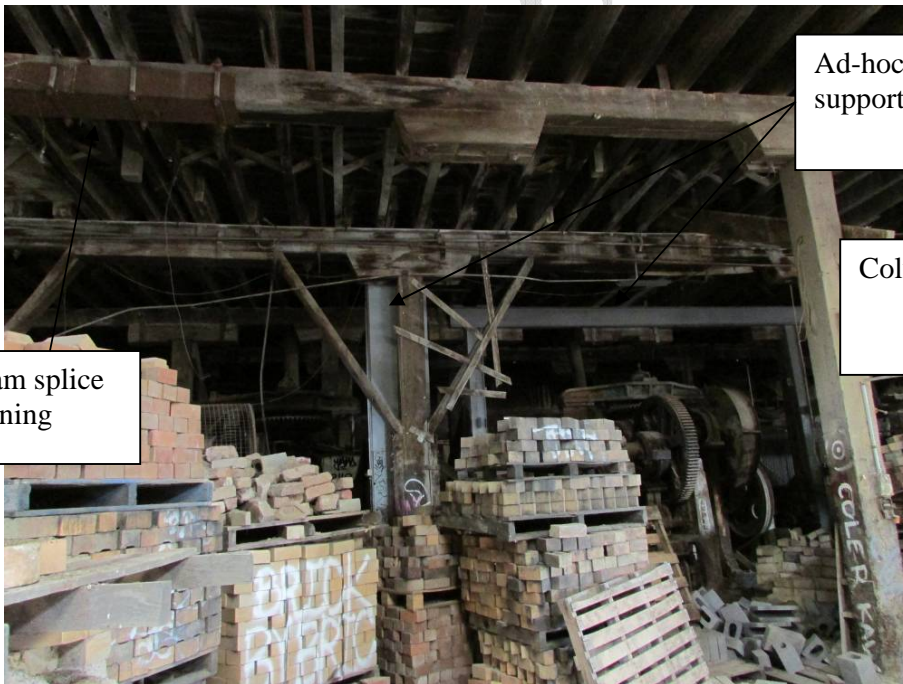
Ad-hoc floor strengthening to support industrial machinery over

Column missing

Floor beam splice strengthening

Building 5 First Floor framing. – Typical examples of poor building and construction practices within the building. These types of practises affect approximately 10 – 15 % of the first floor framing . But it also demonstrates that past practices have intended not to overload the existing/original timber framing

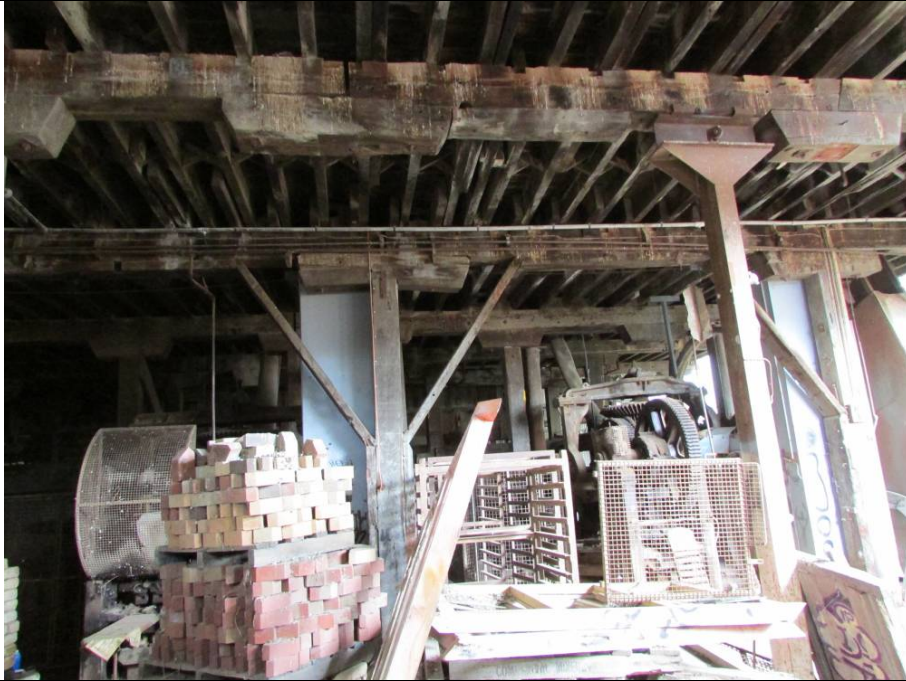
Building 5 – First Floor framing. Past practices associated with altering framing to accommodate the industrial function of the building. The majority of these construction practices, with rudimentary and agricultural are structurally sound

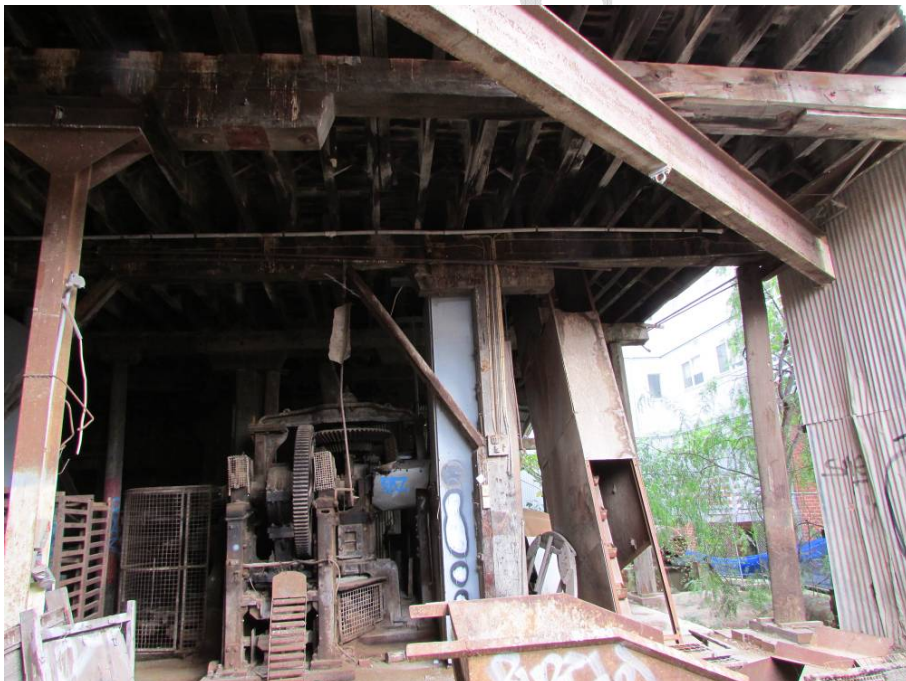
Building 5 First floor framing ad-hoc construction practices. The steel beam is supported by a steel column behind the CI sheeting. The circular post is poor construction practice. This type of poor construction practices affects no more than 10 % of the first floor area.

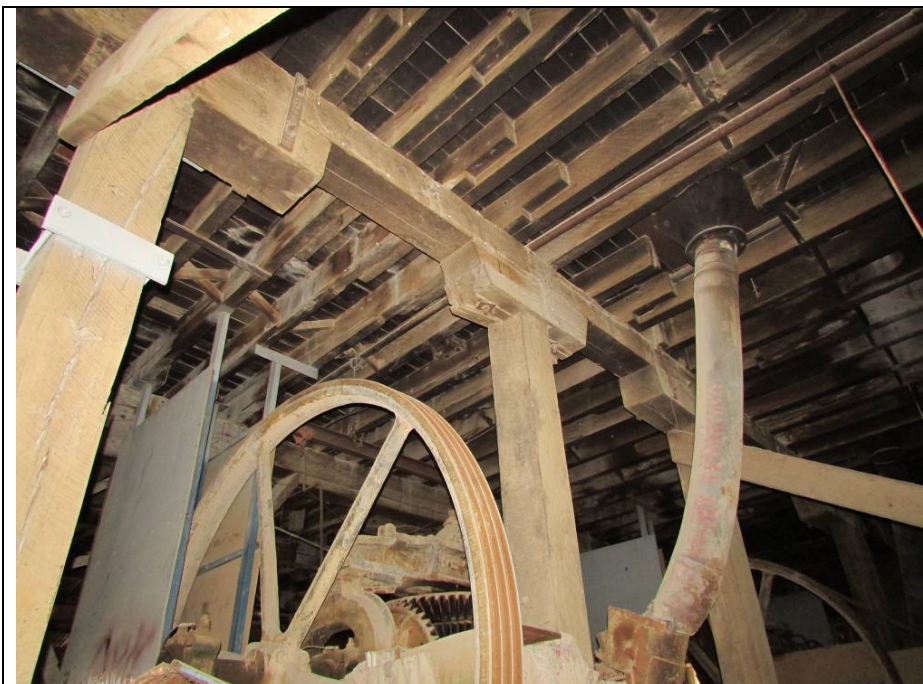
Building 5 – First floor framing over the pressing machinery in the Western portion of the Bld 5. Columns, capitals, beams and floor joist are all in good condition. I suspect also that the flooring is in reasonable condition given the environment that is subject to. Fundamentally the 'structure' is sound

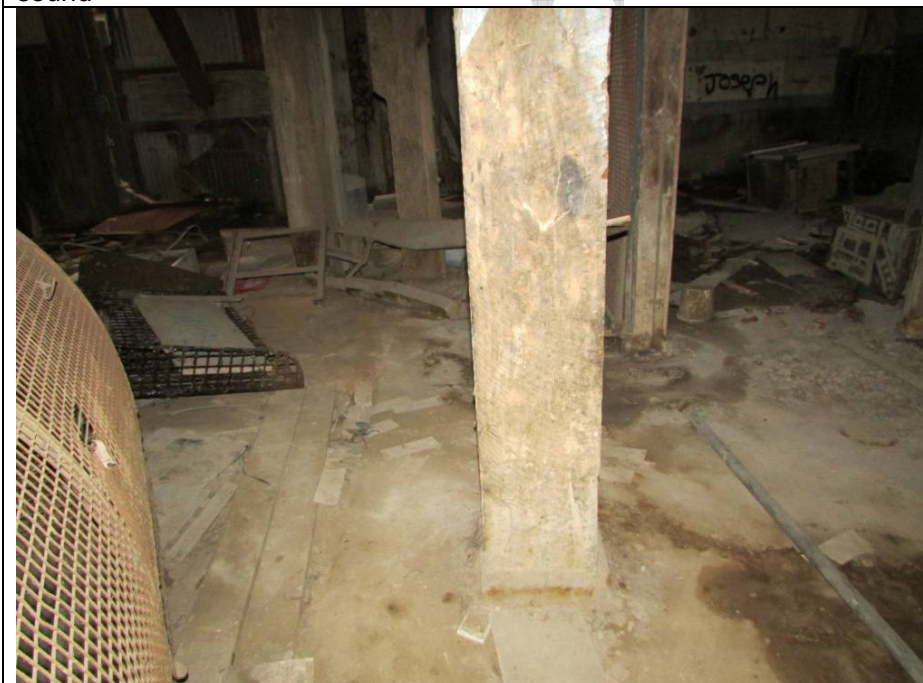
Building 5 First floor framing posts in the western portion of the building near the pressing machinery. This type of construction is consistent with the posts cantilevering to provide structural lateral stability for the building. Post base is sound and in good condition

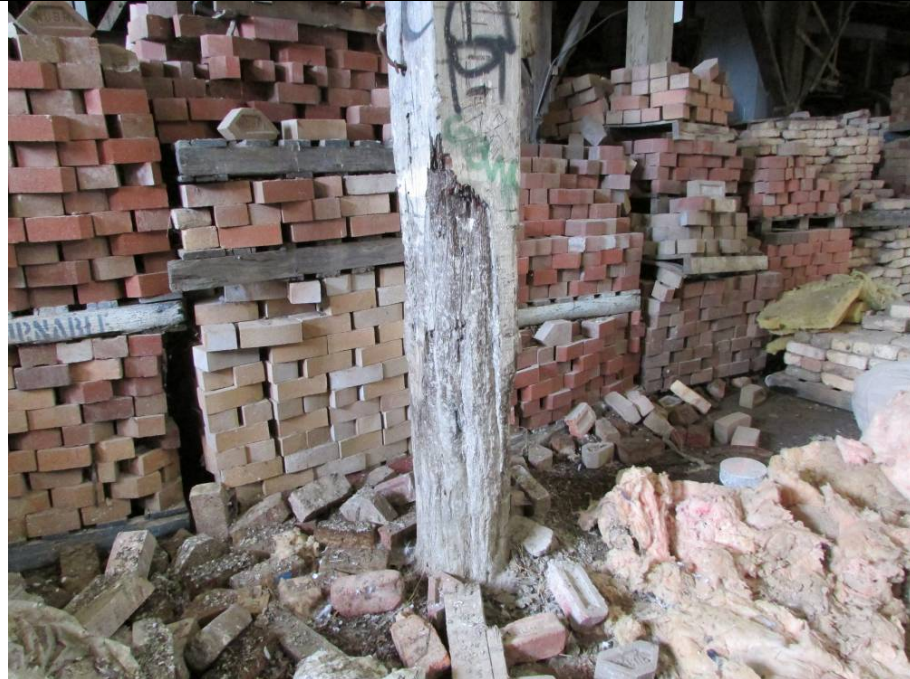
- k) One column location examined in detail exhibited damaged to a height of approximately 1.2m. In my opinion this was consistent with mechanical damage associated with forklift traffic. Remaining timber post heart timber was extremely hard and sound, not exhibiting any decay or rot.

Building 5 First floor framing – Post base. I suspect that this damage is mechanical associated with the movement of materials in the industrial processes of the buildings historical context . Exposed timber is sound and in good conditions

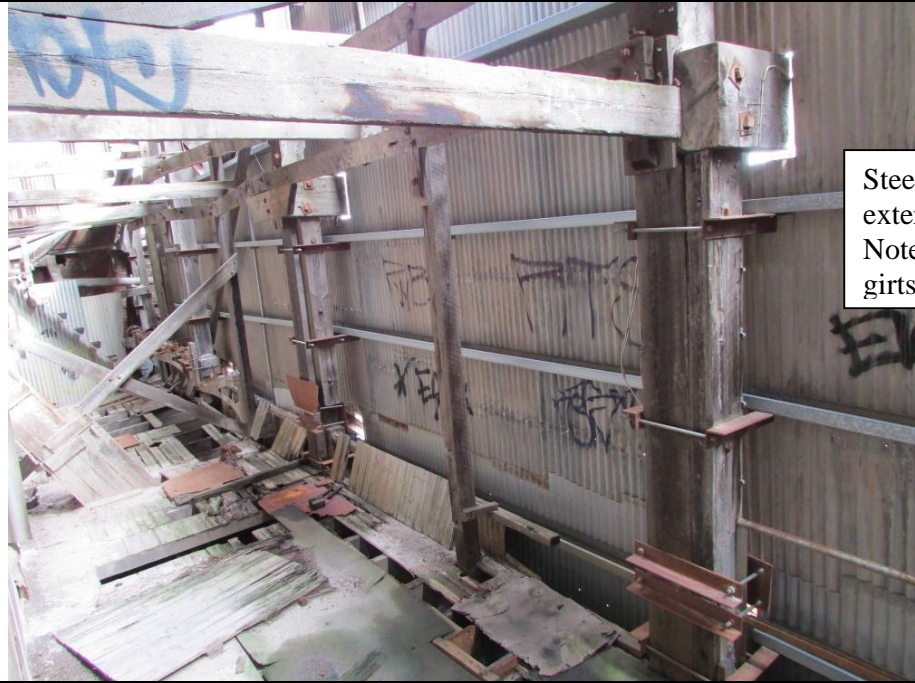
Steel brackets from  
external braces.  
Note non original steel  
girts

Building 5 – Western Annex- Internal – Note bracing connections. The floor of the western annex is lower than Building 5 by approximately 1500mm

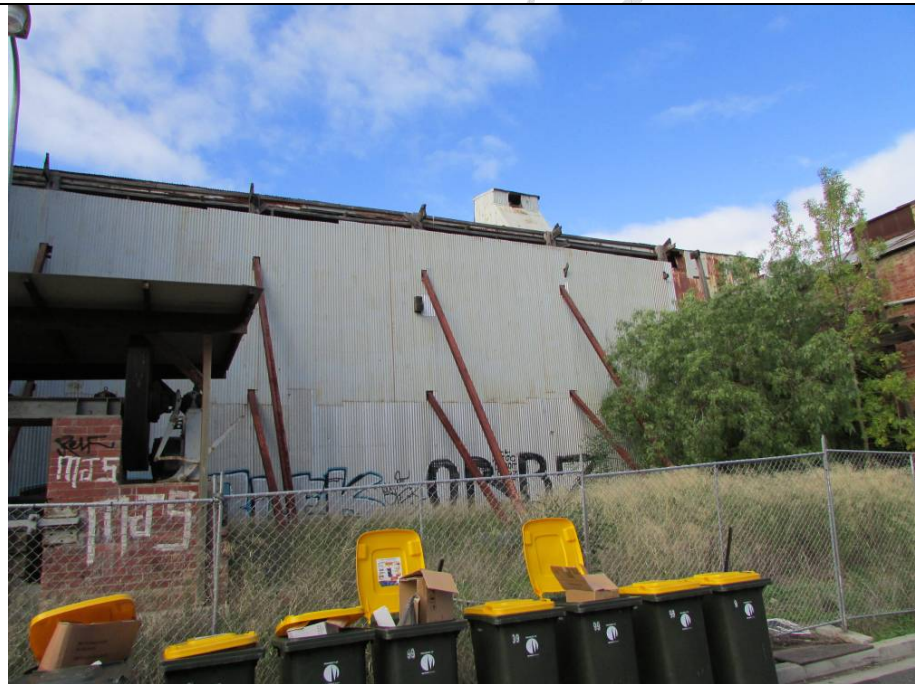
The stability of the Western annex is extremely questionable in the absence of the steel braces observed.

Building 5 – Western Annex external steel bracing frames  
View from Brickworks Drive

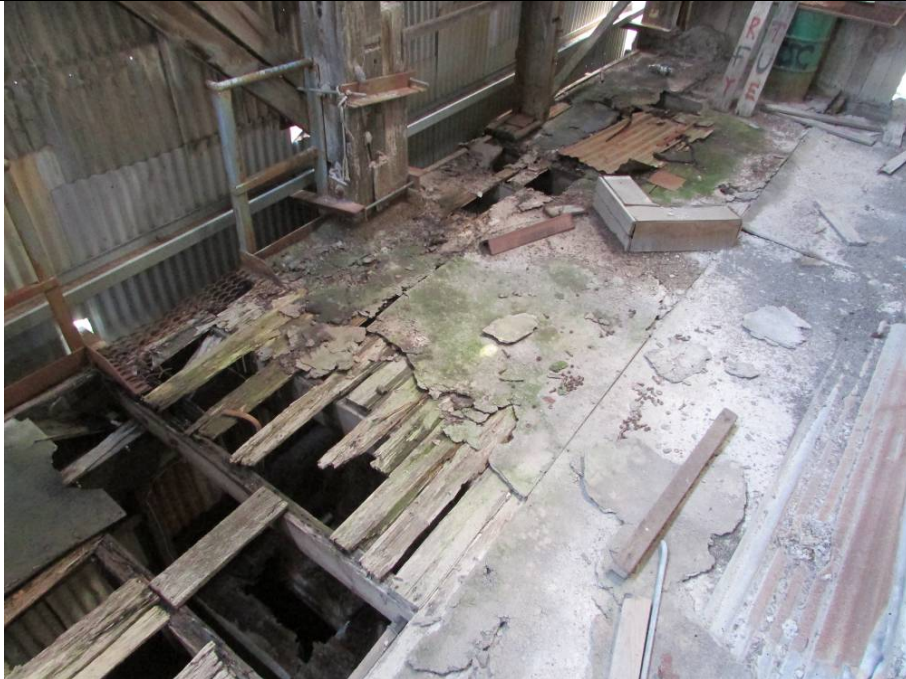
- a) Timber flooring has deteriorated from prolonged exposure to falling damp and adverse affects of weather. This section of the building is condemned as not trafficable for any type of activity in its present condition

Building 5 Western Annex- Flooring badly affected by ingress of water and adverse affects of water over a prolonged period of time and is condemned as structurally unsound

- a. Remove west elevation wall sheeting.
- b. Remove loose construction material and examine support conditions of floor joist timbers on the western edge for conditions from outside the building.
- c. Undertake a condition report on the floor joist timbers . Replace any severely rotted or damaged floor joists
- d. Progressively replace existing rotted condemned flooring with 25 mm structural flooring panels, glued and screw fixed.

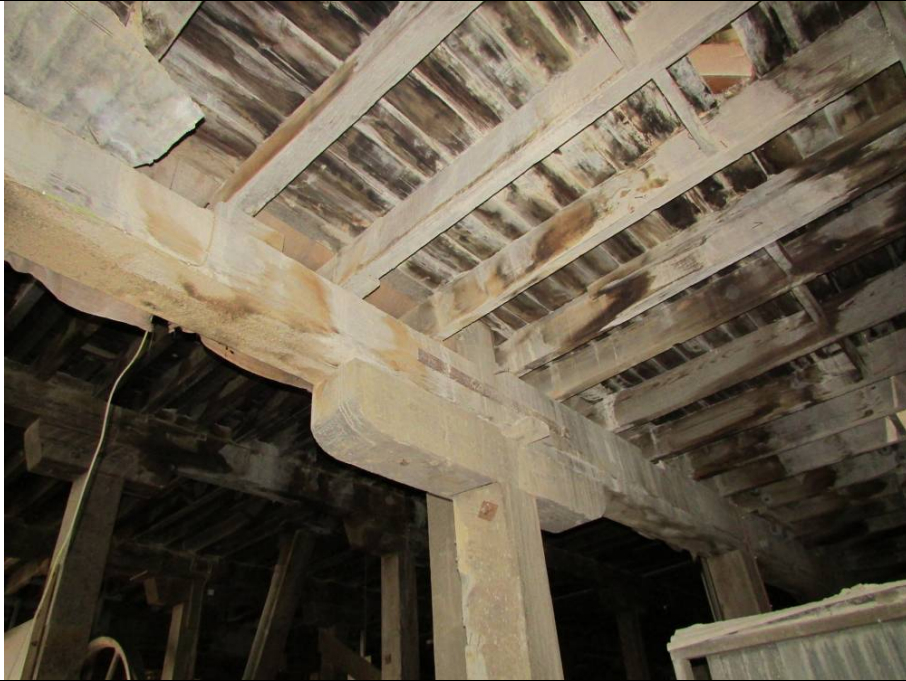
Building 5 – Western Annex. Eastern Edge . Floor joist and other timber properties seem to be sound

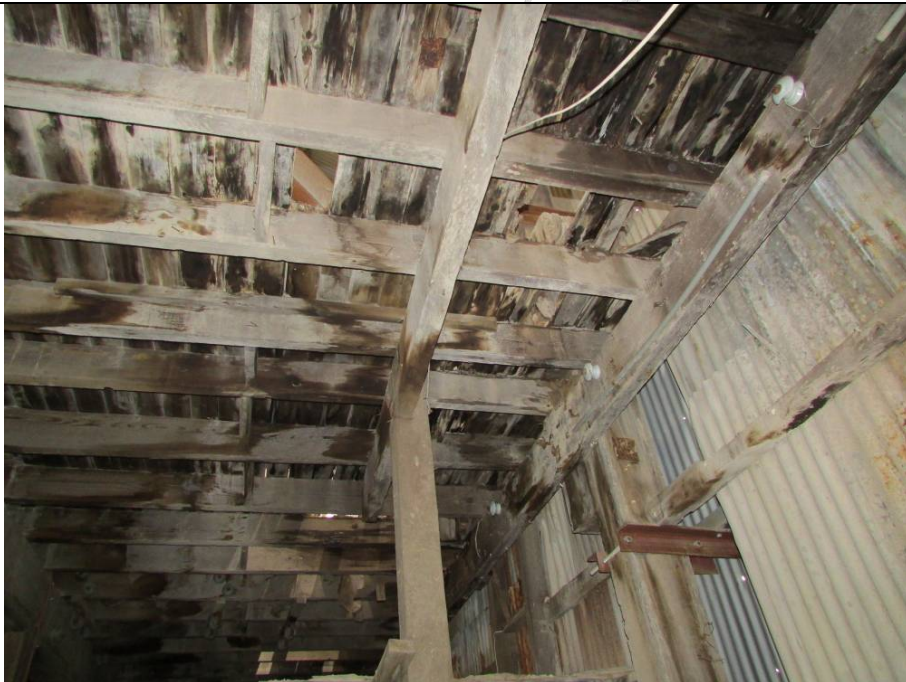
Building 5 – Western Annex – Western Edge . The majority of the section still appears to be sound. This framing is not condemned until additional investigation is undertaken to determine the depths of the top edge surface rot.

I am not convinced that the western annex framing is in danger of collapse. Additional detailed inspection is recommended from external to the building to gauge the end condition of the timber floor joist. The existing joists are robust and of 250 – 300 x 75 mm, I suspect Oregon. If the end condition is sound despite the top 25 – 35 mm of rotted degraded material, these joist would be suitable to receive temporary flooring

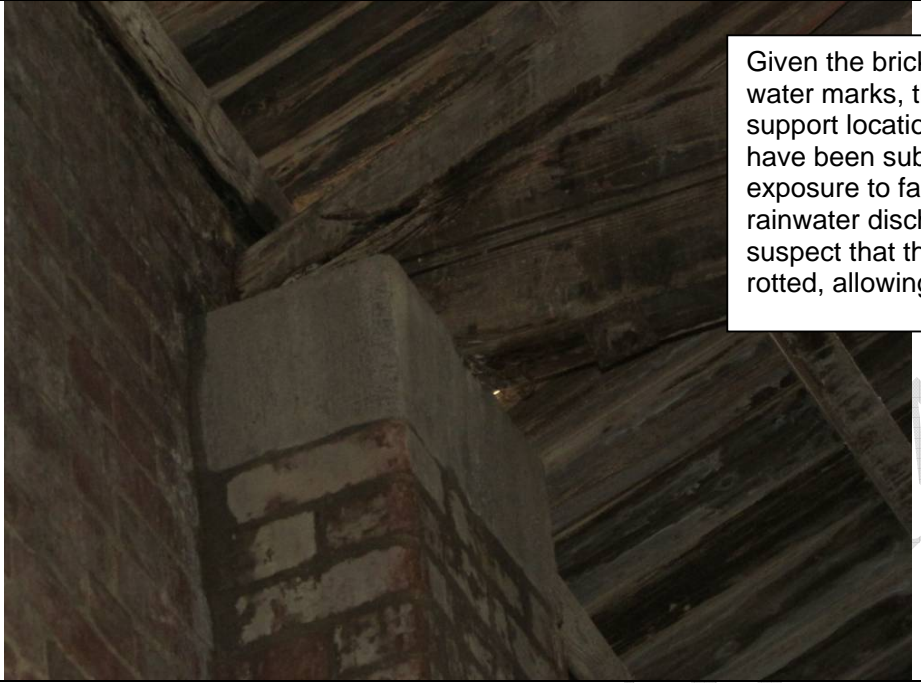
Building 6- Truss heel and support.

- i) Given the water marks and discoloration at the concrete pier cap, I suspect the crushing is the result of prolonged exposures of the timber to ingress of water. If the timbers are soft wood Oregon, this species is known to be non durable and susceptible to rot in an exposed condition

Given the brick discoloration and water marks, the truss heel and support location would appear to have been subject to prolonged exposure to falling damp from rainwater discharge on the roof. I suspect that the timbers have rotted, allowing the truss to rotate

- a. Build an access scaffold external to the building and work platform to access the heel locations of the two timber trusses on the North Wall
- b. Splice onto the damaged heel locations , steel stiffening plates each side to ensure the safety and stability of the trusses.
- c. Examine the timber for condition and devise a strategy for repair .

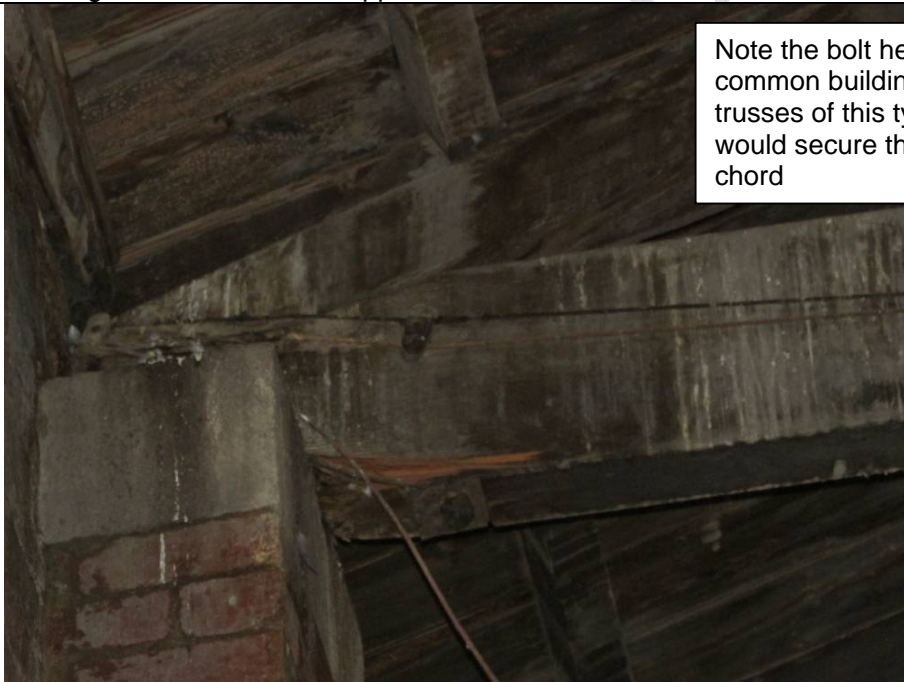
Note the bolt head. Consisted with common building practices for trusses of this type, the through bolt would secure the top and bottom chord

Building 6 – Truss heel distorted and split. Given the lack of discoloration within the split, the split would seem to be historically recent .

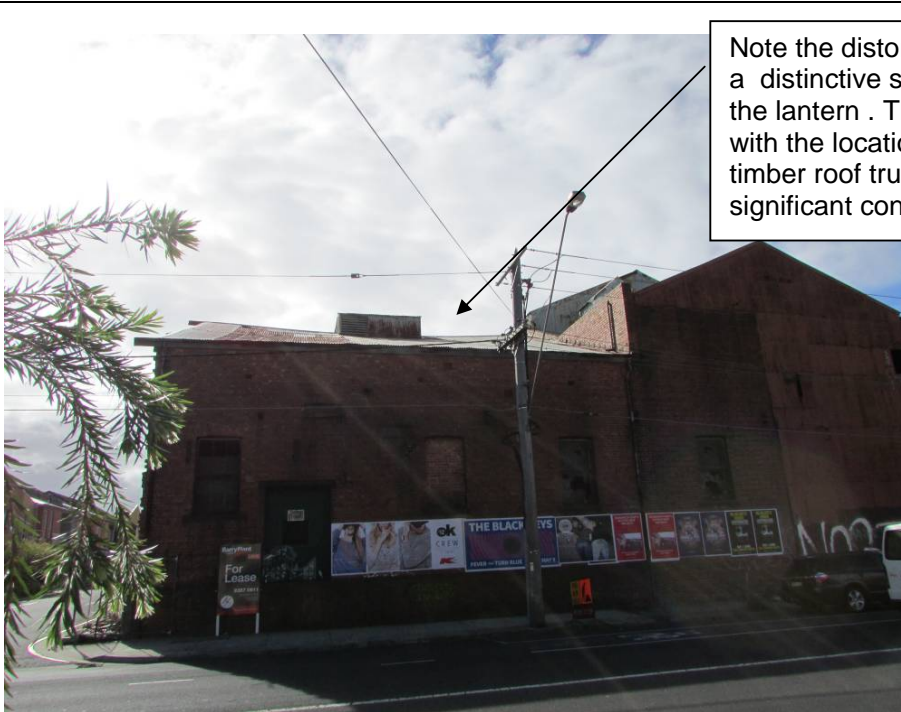
Building 6 – South Elevation

- k) When viewed from outside the building, a considerable and obvious sag is evident in the roof framing. This may be an original condition, or it may be associated with the crushing and splitting of the heel of the timber trusses.

Note the distortion in the roof line, , a distinctive sag at the location of the lantern . This sag is consistent with the location of the two internal timber roof trusses and is of significant concern

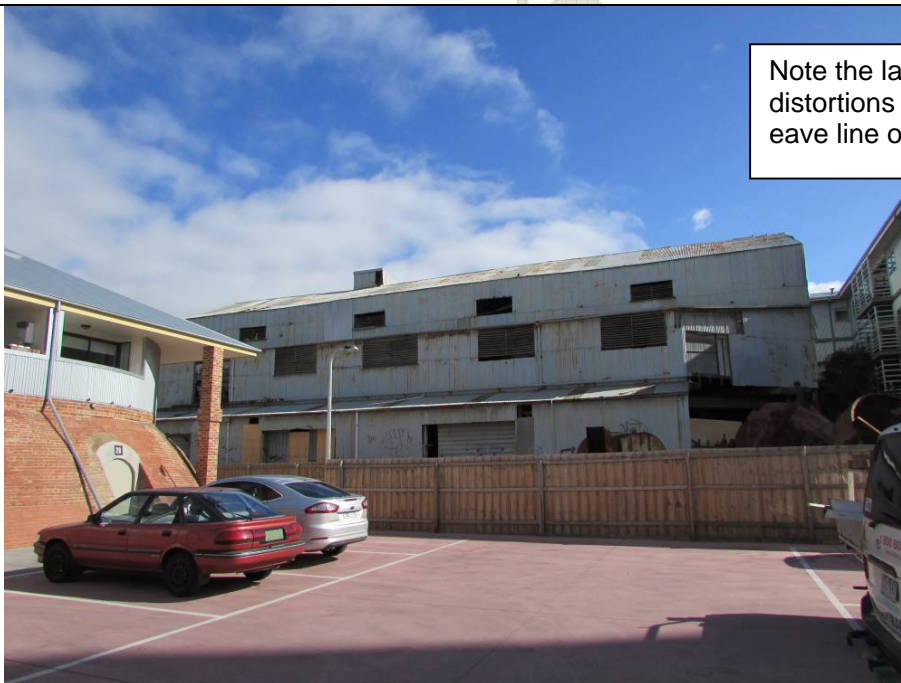
Building 5 – East Elevation

Note the lack of sags and distortions in the ridge and eave line of Building 5
