STRUCTURAL ASSESSMENT REPORT

HOFFMAN BRICKWORKS
FORMER BRICK PRESS BUILDING
CORNER DAWSON STREET AND BRICKWORKS DRIVE
BRUNSWICK, VICTORIA

6952
S4 Rep001 - Dawson Street Brickworks.docx
1
1 April 2014

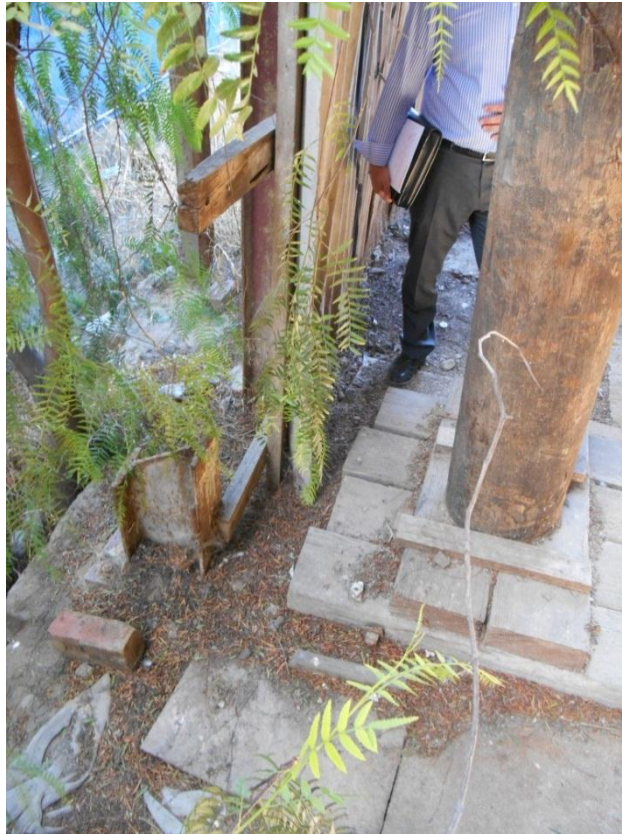
Local demolition works to the north have however caused significant distress to the structure. A series of steel posts along the northern side of the building have been removed, replaced with a series of timber posts locally wedged into position and supporting only by plinths of timber sleepers at ground level (Figure A1-3). The posts are not sufficiently secured to the first floor framing and there is evidence that the posts have moved due to local settlement of their makeshift supports at ground level (Figure A1-4). Further, the easternmost post does not adequately align to support the two timber beams at first floor level that were originally supported by the steel post in this area. As such the posts are not providing an adequate support to the northern side of the structure and the area is not structurally sound.

Figure A1-3 – Remnant section of steel post and timber sleeper support of supplementary post

Similarly at the northern side of the building, we recommend a hoarding be installed to prevent access to the area between the adjacent new construction and the existing structure. Temporary props should also be installed to supplement the support of all first floor elements currently supported by the round timber posts at the northern side of the structure. Raked props should also be installed to the round easternmost post that appears to have settled and shifted out of position. These works are to be installed by a temporary works specialist.

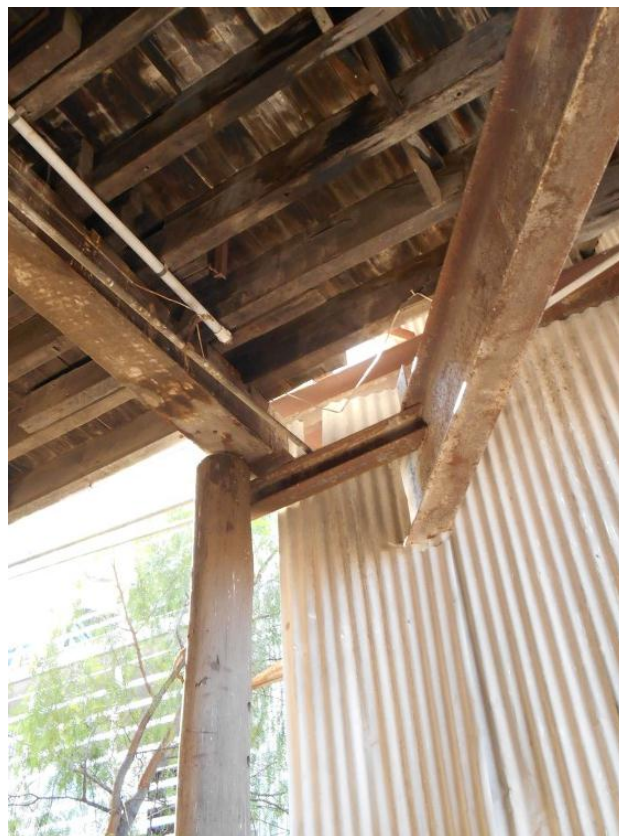
Figure A1-4 – Displaced supplementary timber post beneath timber floor beam

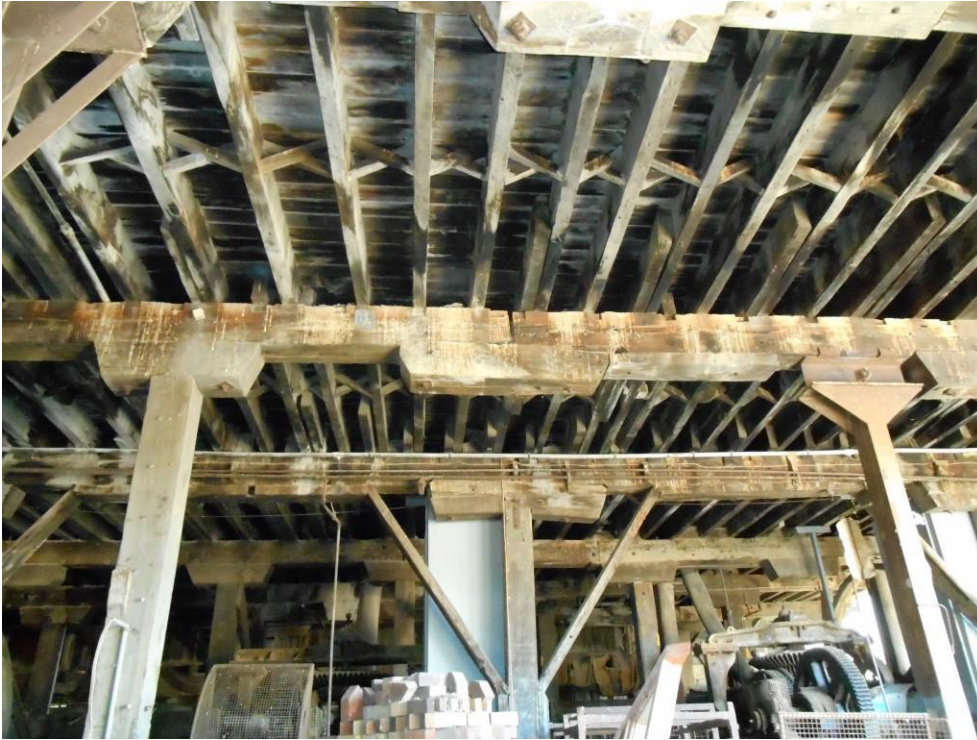
Alterations to the central part of the structure have also caused significant distress to the existing fabric. The most common alteration found throughout the building is the removal of original timber support posts to allow for the installation and operation of machinery at ground floor level. Supplementary posts and support beams have been installed in a few locations, although in the vast majority of areas no strengthening works was observed (Figure A1-5 and Figure A1-6).

Where supplementary posts have been installed at ground floor level, the location of a number of these posts does not suit the arrangement of the first floor beams so that timber splices over original timber posts are currently unsupported (Figure A1-5 to Figure A1-7).

**Figure A1-5 – Removal of timber post below remaining timber corbel.
Free end of floor beams are no longer supported. Beyond, failure of timber corbel.**

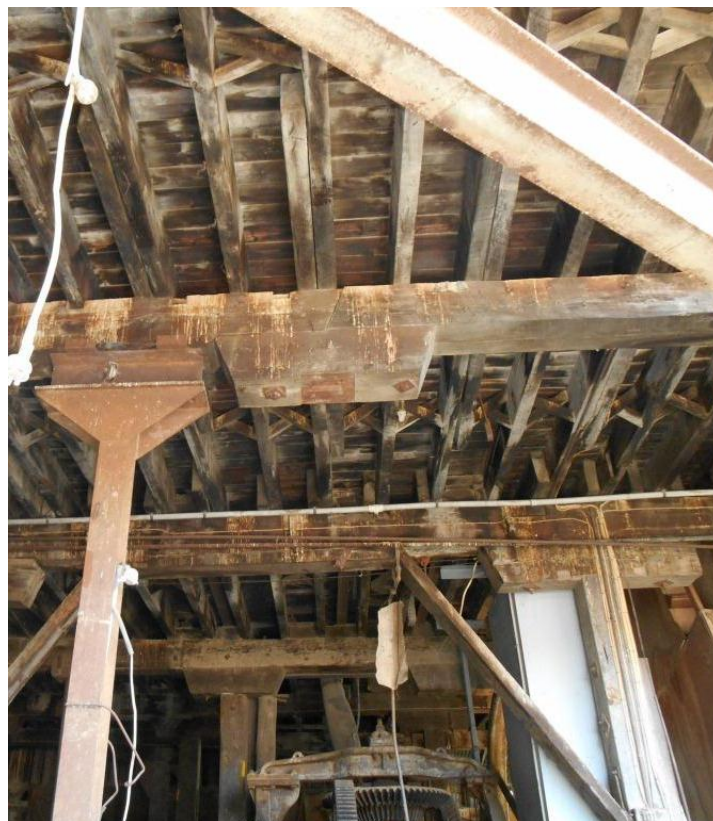
**Figure A1-6 – Removal of timber post below remaining timber corbel.
Spliced end of floor beams are no longer supported. Beyond, failure of timber corbel.**

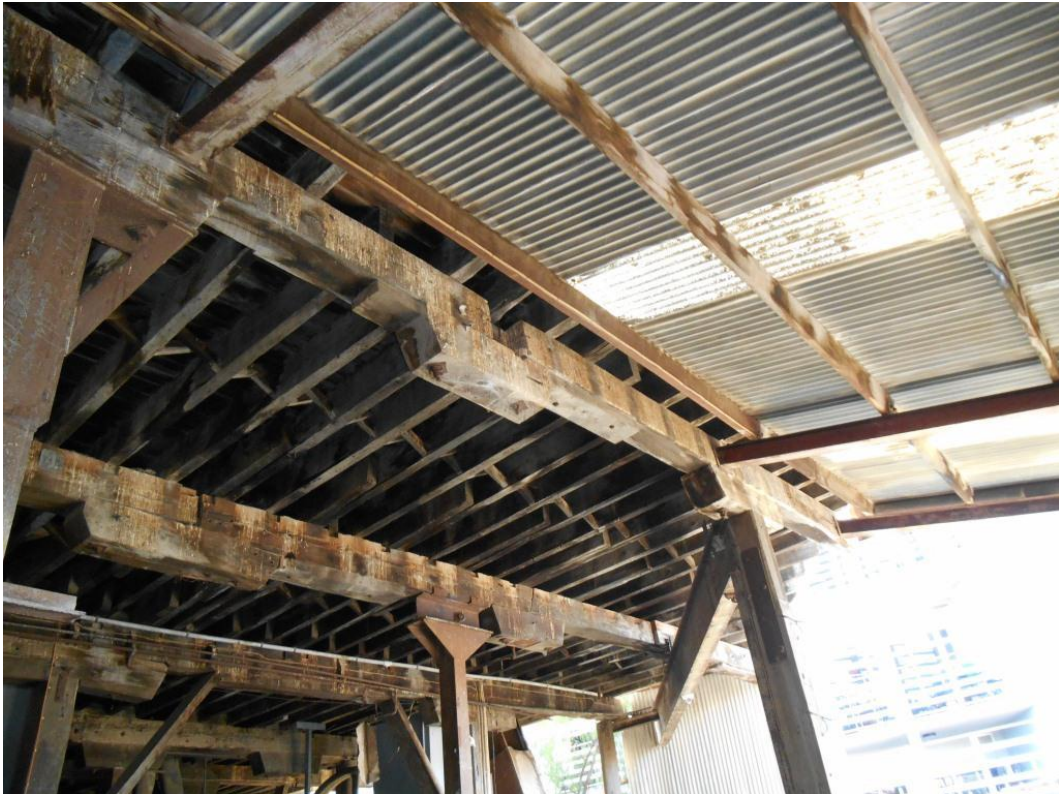
As a result of the removal of posts, many of the first floor beams are currently spanning far in excess of the original spans and are exhibiting clear signs of distress such as excessive deformations and splitting of the timber beams (Figure A1-7). In some areas, the additional load from the increased beam spans has also affected the timber posts with significant splitting and bowing of timber posts in a number of locations (Figure A1-8).

Figure A1-7 – Horizontal splitting of inadequately supported timber floor beams.

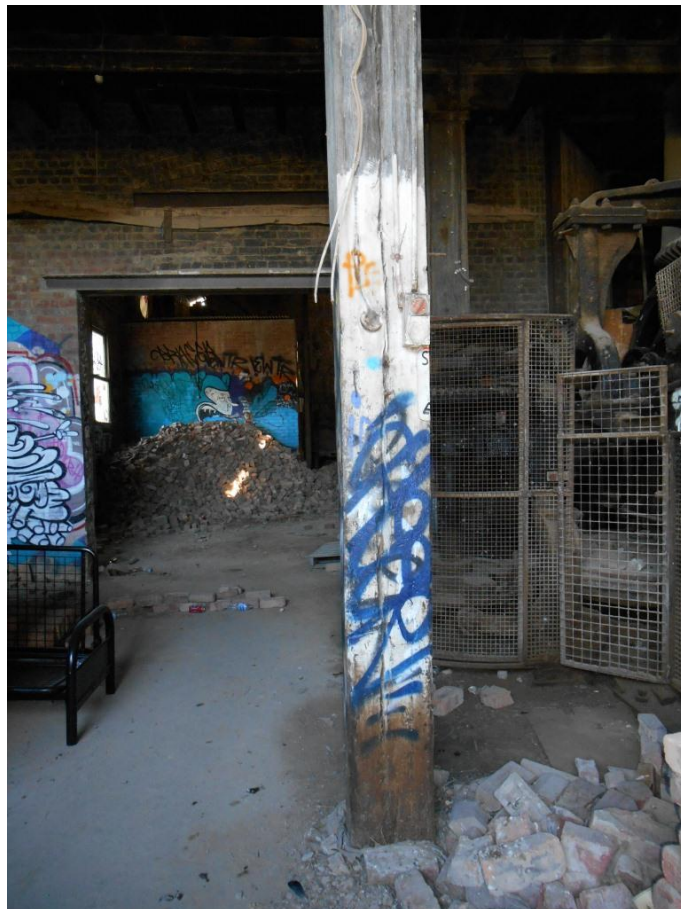
Figure A1-8 – Vertical splitting of timber posts.

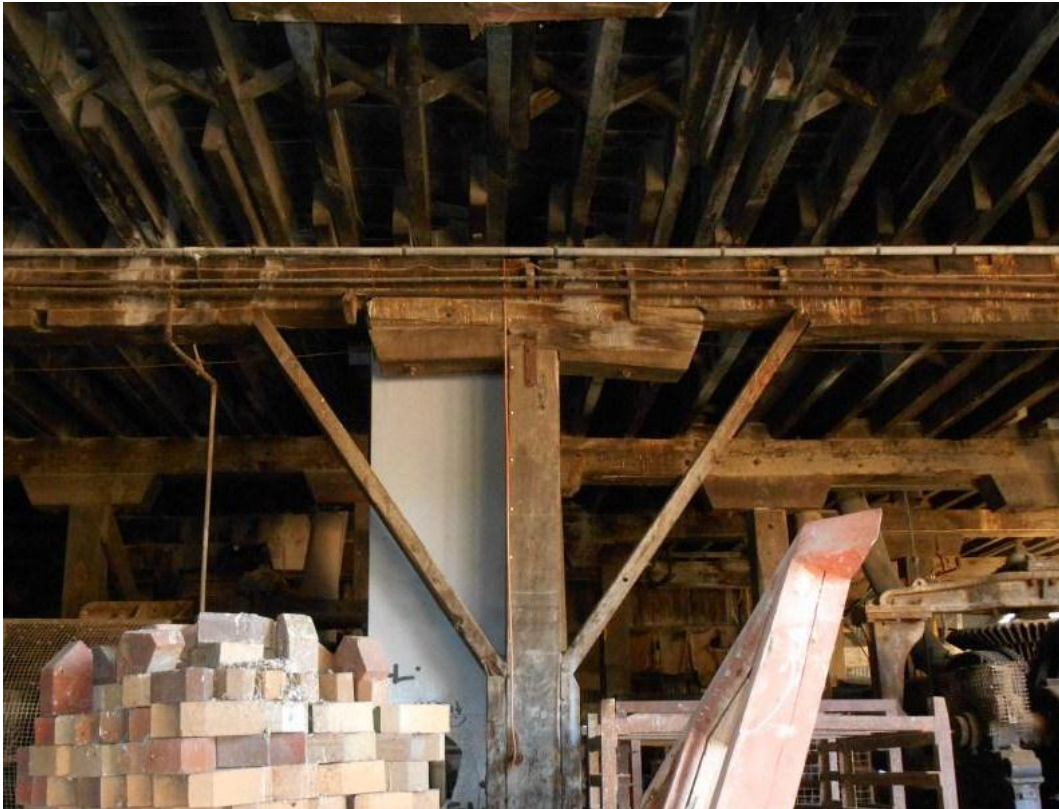
In some areas, natural deterioration of the timber either by fungal decay or pests has also appeared to promote failure of the elements. Such deterioration was particularly evident at a column capital at the northern end of the central section (Figure A1-9).

Figure A1-9 – Failure of column capital

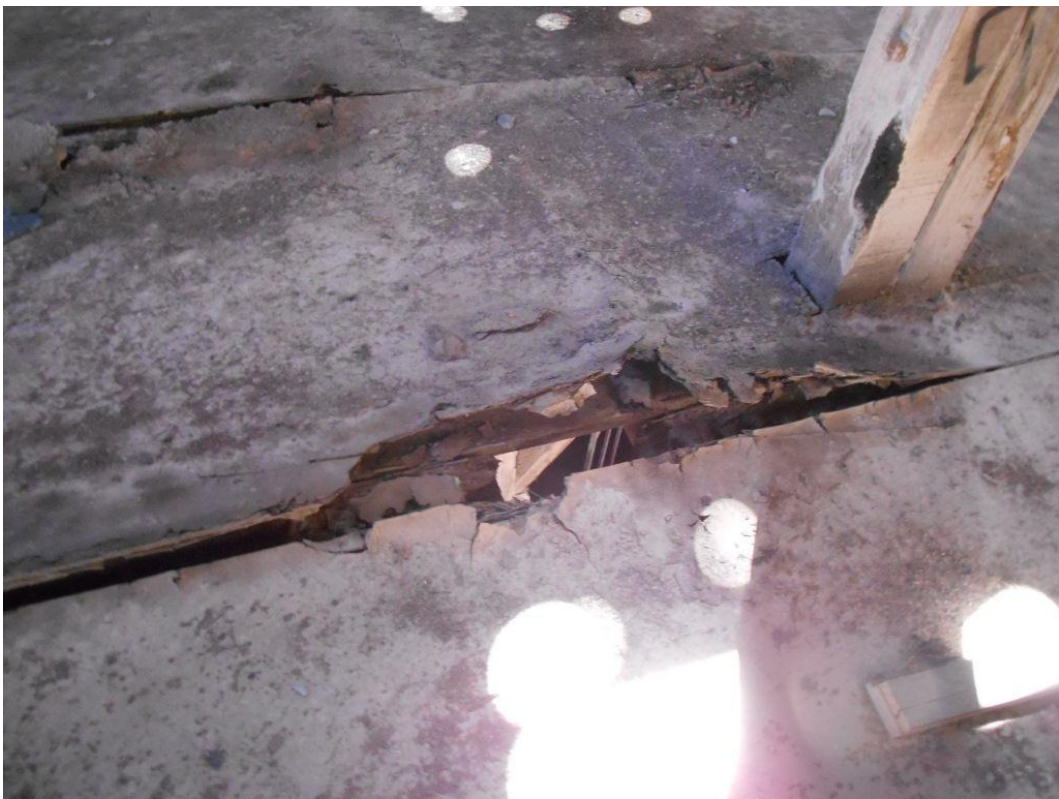
At first floor level, the timber floor framing and flooring has been significantly affected by moisture ingress. A number of sections of the original roofing are no longer in place and this has permitted water penetration over a significant number of years. As a result, sections of the timber flooring has decayed and long since collapsed (Figure A1-10). Many other areas of the timber flooring are

Figure A1-10 – Local collapse of timber flooring

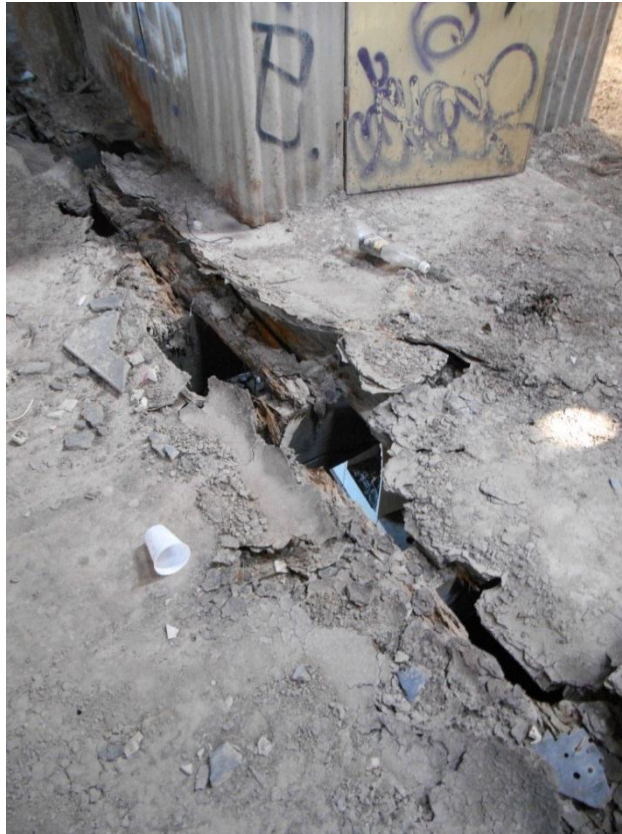
structurally unsound and therefore are unsuitable to traverse. Large areas of the floor have been covered by a supplementary composite lining, however this lining also has been impacted by moisture ingress and is displaying evidence of decay (Figure A1-11).

Figure A1-11 – Decay and collapse of timber floor and lining.

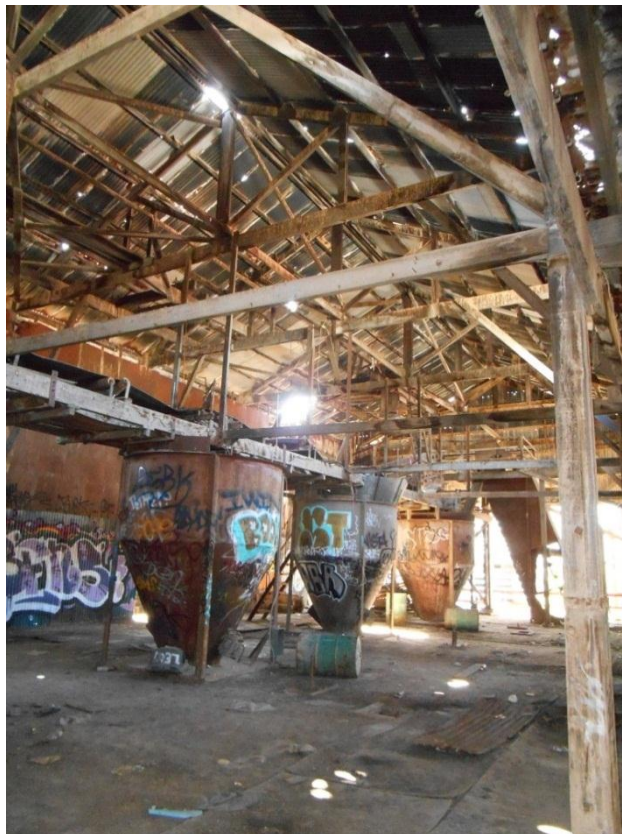
The timber posts, timber roof trusses and the supplementary roof and wall framing were not able to be closely inspected due to limitations of safe access on site (Figure A1-12). The elements have been subjected to many years of moisture ingress with the ongoing deterioration of the roof sheeting. As such, it is likely that the timber truss connections and the connections between other timber members will be affected by rust which may have led to local splitting of the timber elements at these connections.

Figure A1-12 – Timber trusses and framing at roof level.

As stated in Section 4, further investigations would be required of the timber framing at roof level of the central section of the building to determine the precise morphology and existing conditions. Unfortunately, such investigations cannot safely be completed from within the structure due to the significant deterioration of the flooring both at first floor level and within the post and beam framing below. External access by cherry picker or similar may be permissible to some limited elements, however a temporary works specialist would be required to ensure that the trusses remain in a stable

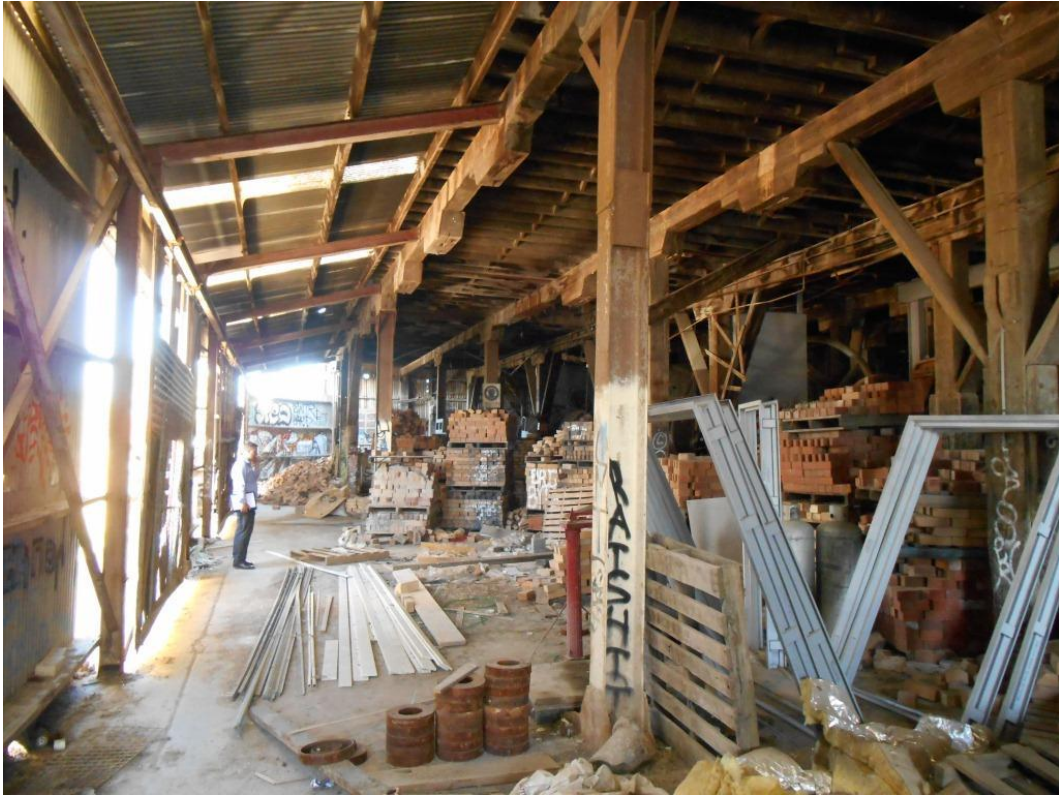
As stated in Section 3, the eastern section comprises a late single storey addition along the eastern side of the building. The structure comprises steel posts and beams aligned east-west with north-south aligned timber rafters (Figure A1-13). The posts are connected by steel ties and cross braces aligned north-south at regular intervals along the eastern external wall.

Figure A1-13 – Eastern extension, at left of photo.

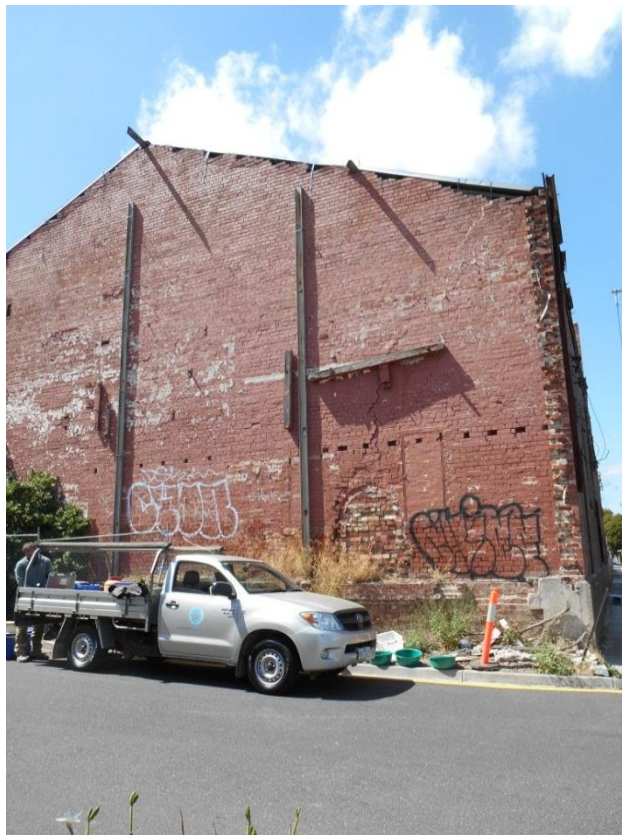
Similarly to the remainder of the building, the south-west section has been left to deteriorate over many years. As a result, the guttering and flashings along the southern and western external walls have long since deteriorated and have mostly collapsed. This damage has subsequently permitted moisture ingress into the top of the external walls which has eroded to the mortar and softened the bricks. A number of bricks along the top of the western wall have been lost, either attached to collapsing flashings or due to other actions. Along this wall there remain a large number of loose and displaced bricks that are at risk of collapse (Figure A1-14 and Figure A1-15).

Figure A1-14 – South-west section, western external wall.

The top of the masonry walls along the western and southern external walls are significantly deteriorated due to moisture penetration and decay, and the flashing and guttering elements have partially or completely collapsed. Along the western external wall, there are loose bricks along the top of the wall that are at risk of collapse. The area beneath this section of the wall should be hoarded to prevent access and the risk of harm due to local brick collapse (Figure A1-18).

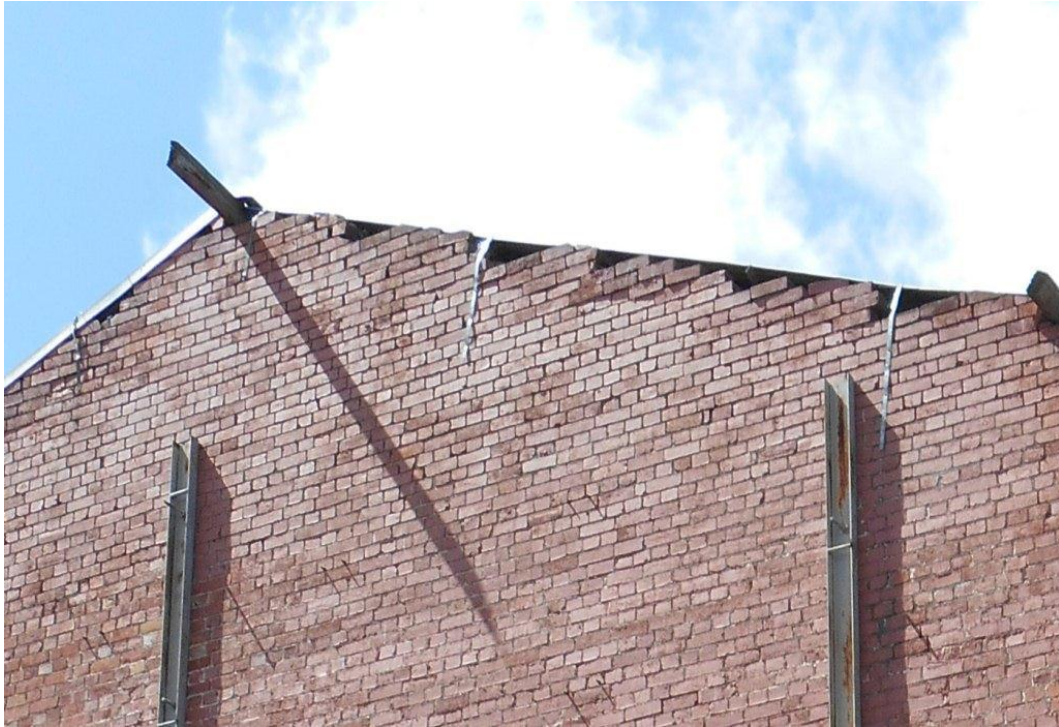
Figure A1-15 – Detail of damaged and unstable bricks along western wall.

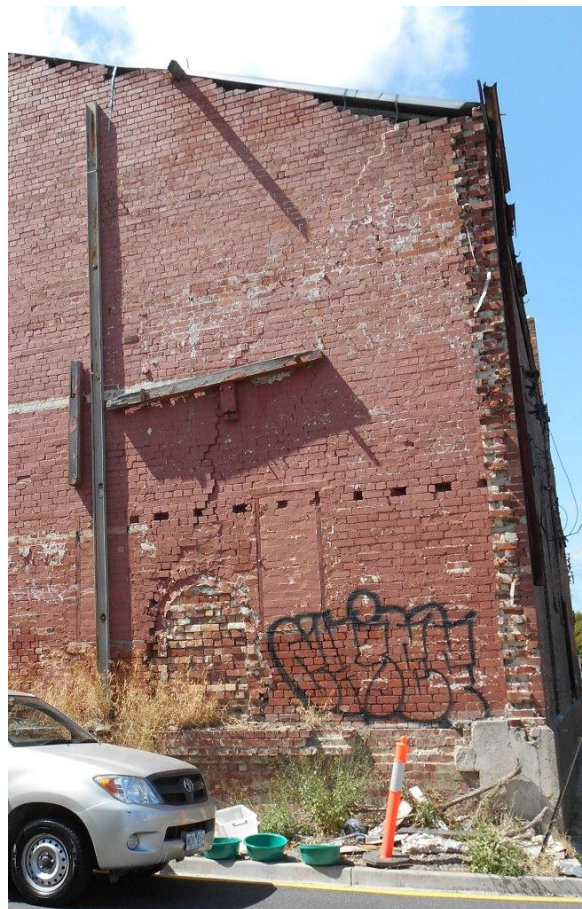
In addition, there is significant cracking within the western brick masonry wall extending from ground level approximately four metres north of Dawson Street to the top of the wall at the Dawson Street façade. The cracking regularly exhibits a lateral displacement of approximately 15mm which indicates that the wall is no longer acting as an integral structure, but two separate elements moving independently both laterally and vertically (Figure A1-16).

Figure A1-16 – Detail of cracked bricks along western wall.

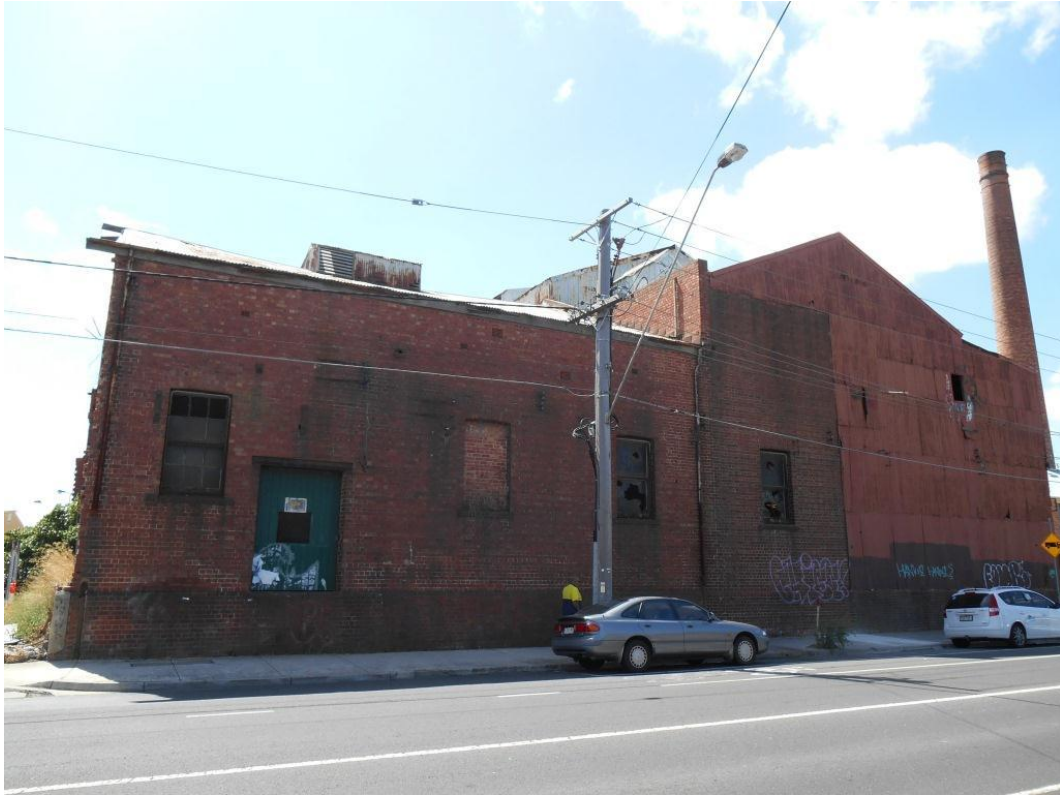
Figure A1-17 – Southern elevation of the building.

Along the southern wall, the small remnant sections of guttering and downpipes should be immediately removed as they are also at risk of collapse, and the condition of the timber fascia board and masonry should be inspected as part of this process (Figure A1-17). It is expected that both the timber and masonry will be found to be deteriorated due to moisture ingress. For these reasons and given the observed conditions of the internal framing, it is our recommendation to install a temporary gantry over the footpath at the north side of Dawson Street for the full width of the subject building (Figure A1-18). The car parks immediately adjacent to the building also should not be available for use. The street is a major thoroughfare and we believe that the risk of damage to pedestrians or private property is too great.
